ARCC UPDATE

April 2011

Valve Seal Replacement

by George Beston, Cobourg

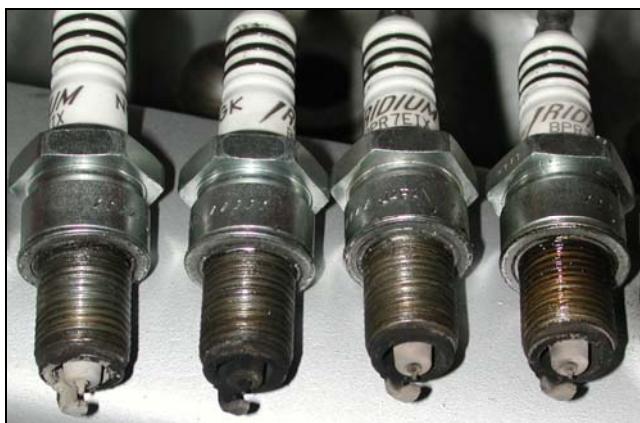
Spark plug inspection. Photo by George Beston.

Well, the numbers look really good. They certainly don't indicate any sealing issues with the rings. The spark plug from cylinder #3 was definitely a lot darker than the others, but it wasn't fouled badly enough to interfere with ignition. The only logical conclusion I could come up with was that some oil must be getting past the intake valve guide seal on this cylinder. This sent me off on a quest to figure out how to change the seal with the least work.

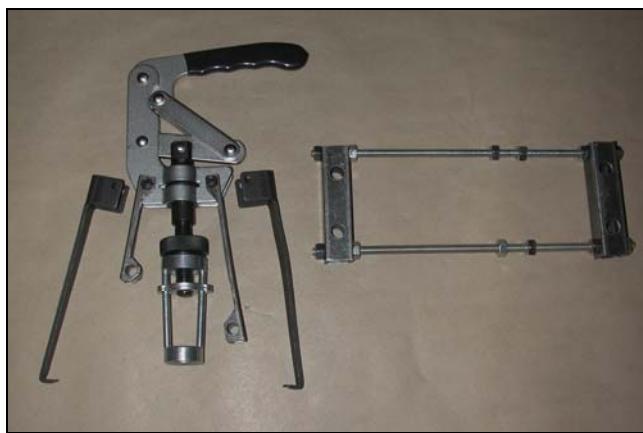
To compress the valve springs, an overhead valve spring compressor was adapted for the purpose. As purchased, it couldn't be used in this application because the hooked arms for gripping the spring could never fit between the tappet bore and outer spring. The adaptation consisted of making up some arms of staggered length to compensate for the angle of the valve (40° off vertical) and the fabrication of a jig to hold the ends of these arms and to bolt the assembly down over the cam bearing studs.

The materials used were pretty basic. The new arms and the cam stud fittings were cut from $\frac{3}{4}$ " square tubing, and $\frac{1}{4}$ " threaded rod was used to provide the anchor for the compressor.

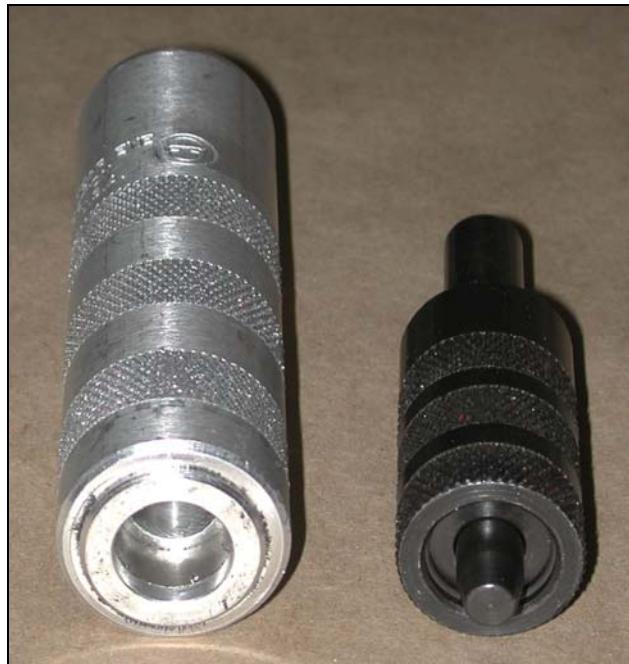
This is Lisle's valve keeper removal and installer tool, catalogue #36200. The idea is to use the silver piece on the left to remove the retainer and keepers. There's a strong ring magnet in the opening, so once the springs have been compressed by pushing on the tool the keepers are drawn to the magnet and it's all over. To install the keepers, the keepers and retainer are loaded onto the spring-loaded retractable post in the middle of the black part of the tool. As the tool is pushed down to compress the springs, the post is up against the end of the valve stem. It retracts into the tool and the keepers are pushed down around the end of the valve stem.

The Lisle tool was used to remove the retainer and keepers and worked like a charm. Within seconds, the retainer, keepers and outer valve spring were sitting on the magnetic end of the tool free and clear of the engine.

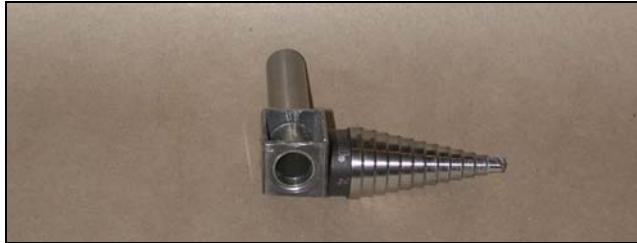
After lifting out the inner spring, the old seal was removed using curved needle nose pliers and replaced with a new one using an insertion tool fabricated for the purpose with $\frac{1}{2}$ " round tubing, $\frac{3}{4}$ " square tubing and openings cut and tapered for the purpose with a Unibit:

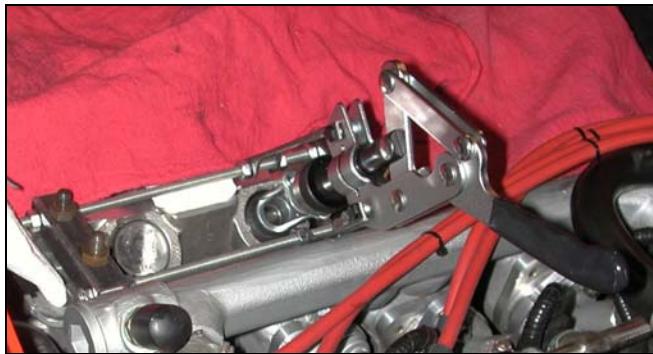
So, the overhead compressor was brought to bear on the problem:

At this point it was a fairly easy procedure to compress the springs, move the keepers into the appropriate location with a small screwdriver, and release the compressor again.

The reassembly operation ran into a small snag because the Lisle tool could not get the keepers all the way down into the correct spot. They were holding somehow, but the tops of the keepers were above the end of the valve stem, which won't do!
